# Manhole Inspection Summary

Manhole # S33I\_\_006MH

Insp Date: **3/26/08 7:39 AM**

**Location** Address: **200 w. pratt**

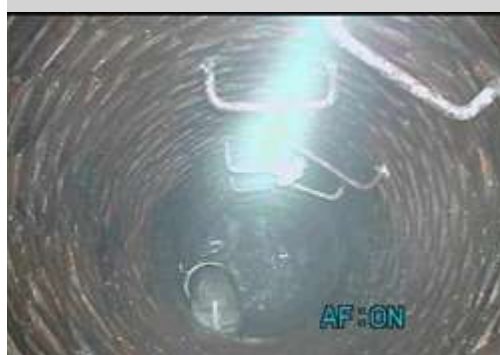
Top View

Can Not Get Better Picture. Too Much Steam

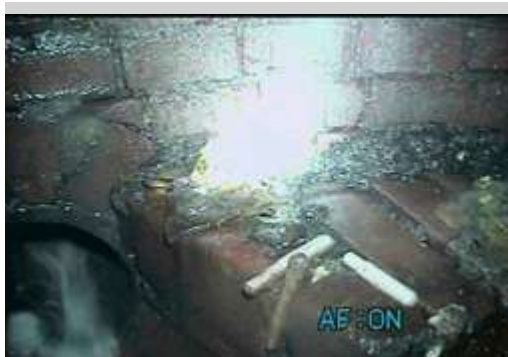
misc

bench debris

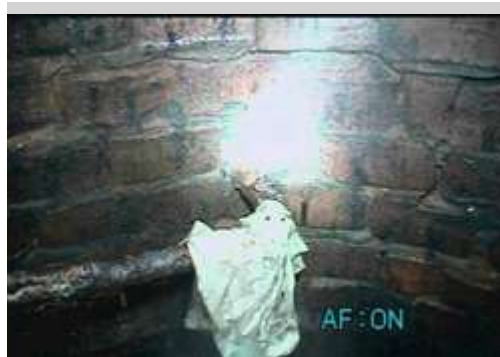
Defect 4

☒ **Evidence Of Surcharge** Depth: **9** (ft.) ☐ Active Surcharge Present

evidence of surcharge

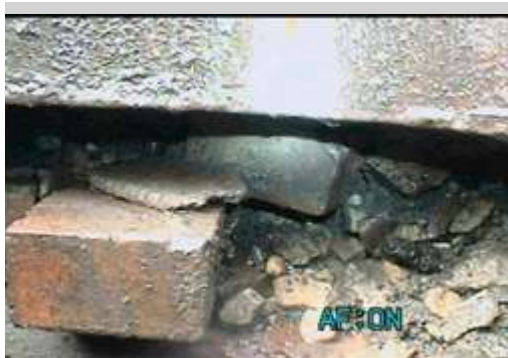
Defect 3

Condition: ☐ Sound ☐ Cracked ☐ Root Intrusion ☒ **Loose Brick** ☒ **Deteriorated**

chimney loose bricks,deteriorated,  
Frame Adj

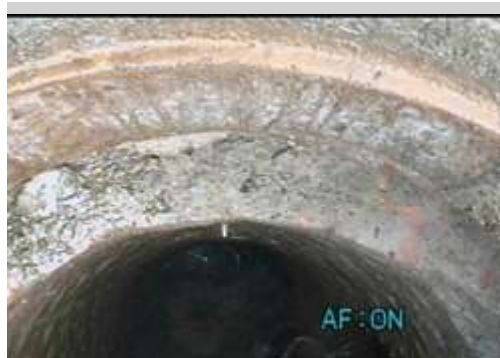
Defect 2

Offset: **3** (in.)

offset

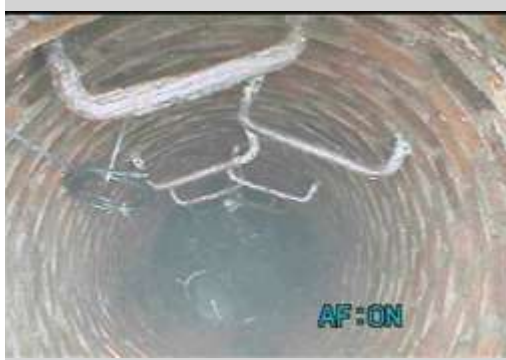
Defect 1

Count: **17** Missing: **0** ☒ **Corroded**

Steps

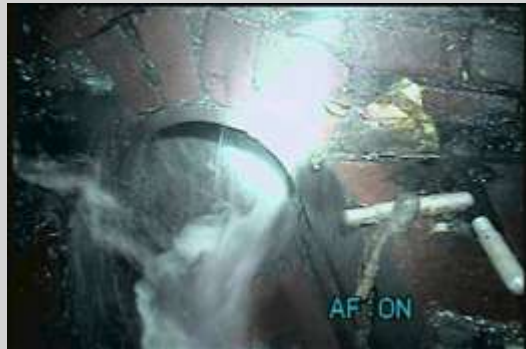
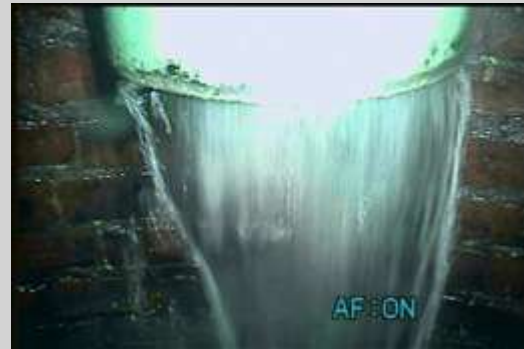
10 O'Clock Inflow

10 in. Circular Gravity Sewer

Pipe In @ 10 O'Clock

Drop In @ 10 O'Clock

Drop: **Inside** **Direct**

Drop Condition: **Open**
